SUBJECT: CLAIM #WCP97

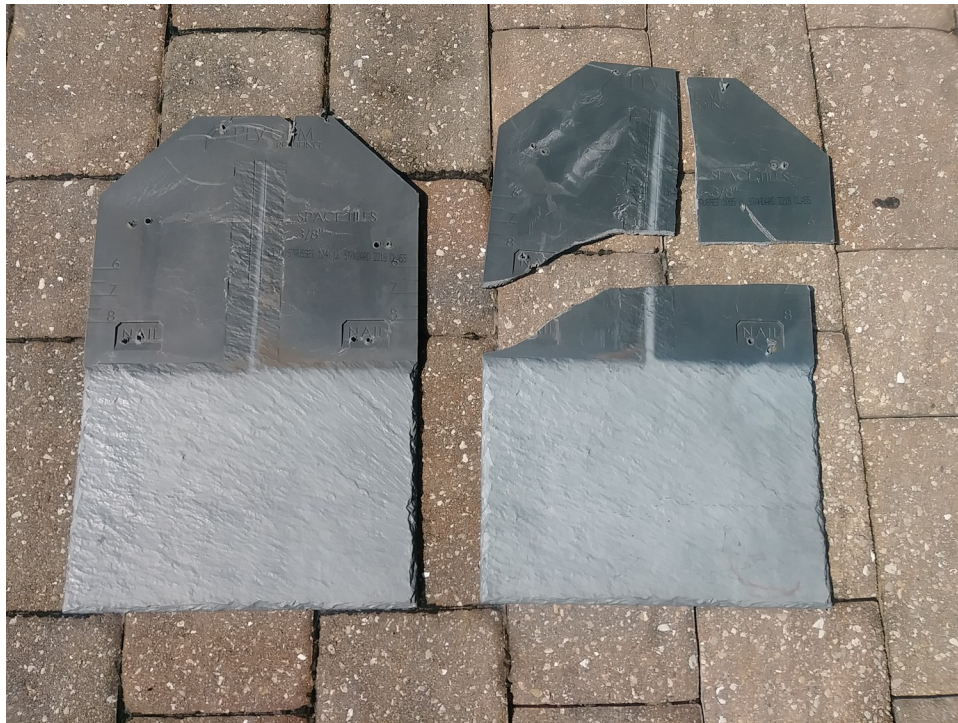
As requested in your letter of September 22, 2021 I have enclosed a sample of the affected area. I have also provided an image of removed Ply Gem Engineered Roofing tiles. As you can see from the photo the exposed portion of the tile is exhibiting significant fading. My colorimeter reading shows fading of about 20 hunter units, far in excess of the 4 hunter units limit specified in the warranty. Also shown is an image of a tile which broke into three pieces while being removed. This indicates to me that structural integrity of the tiles is also compromised.
